# Singapore’s NTU Gaia building mould issue: Condensation and rain exposure the culprits, not timber, say experts

By Malay Mail

Thursday, 29 Aug 2024 1:27 PM MYT

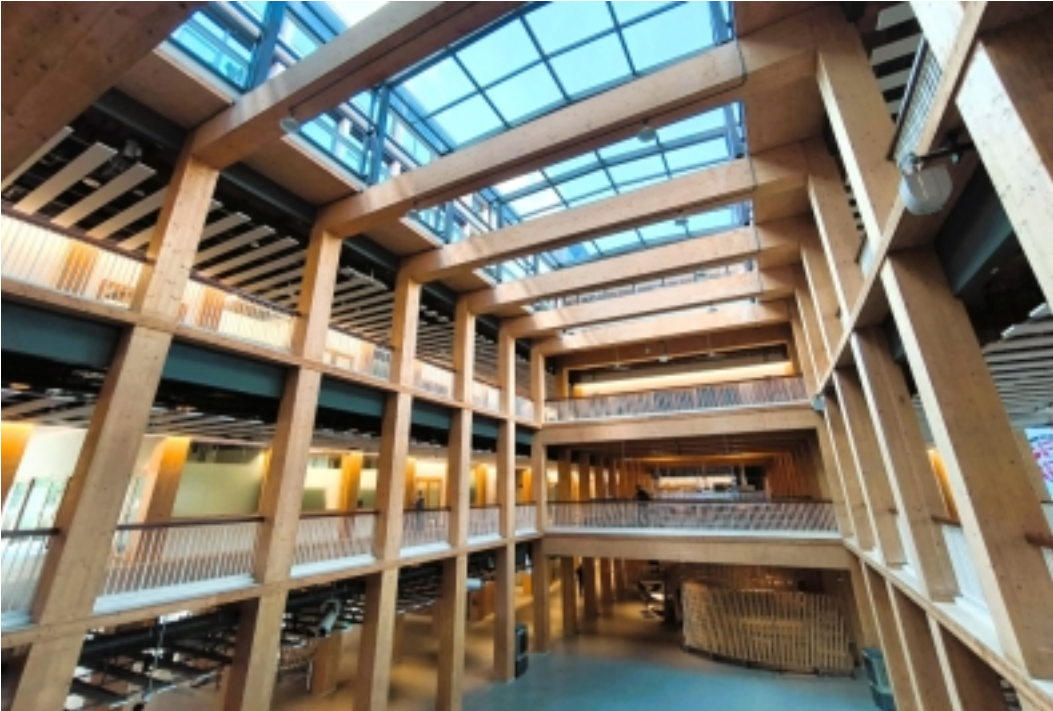
The interior of Gaia and its skylight. Associate professor Tham Kwok Wai, an expert in Indoor Air Quality, and associate professor Shinya Okuda, an award-winning architect specialising in timber, both assessed Gaia and confirmed that the timber itself did not cause the mould growth. They identified that condensation and rain were the primary factors, a statement issued by NTU said yesterday. — Picture courtesy of NTU Singapore
