## Help or horror? Scientists develop 'diving suits' to help cyborg cockroaches conduct underwater search-and-rescue (VIDEO)

By Malay Mail

First Published: Monday, 06 Jul 2026 4:24 PM MYT

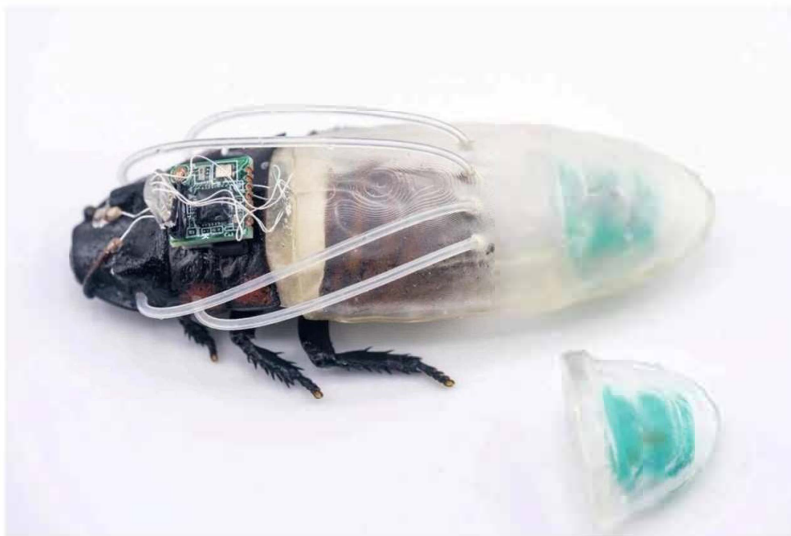
The Straits Times reported that the suit allows the insects to survive and move underwater for up to three hours by supplying oxygen directly to their respiratory system. — NTU pic

The suit consists of a tiny chemical oxygen-generation tank, a soft waterproof shell and four silicone tubes that channel oxygen to the cockroach's spiracles — small openings that connect to its respiratory system. Diluted hydrogen peroxide is injected into the 3D-printed tank, where it reacts with manganese dioxide to release oxygen. Researchers said the tubes can be removed without harming the insects, which were treated in accordance with research guidelines.
